Manhole Inspection Summary

Manhole # S45II_039MH

Insp Date: **4/29/08 10:18 AM**

Location Address: **Washington St**

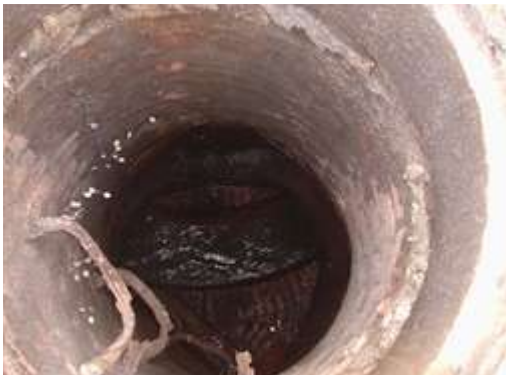
Defect 1

Condition: ☐ Sound ☐ Cracked ☐ Root Intrusion ☒ **Loose Brick** ☐ Deteriorated

loose bricks

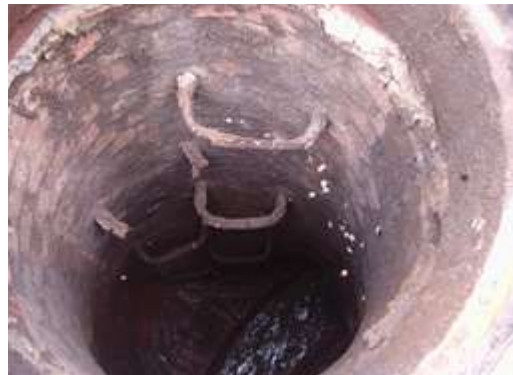
Defect 2

Infiltration: ☐ None ☐ Joint ☐ Cracks ☒ **Mortar** ☐ Roots ☐ Wall

infiltration

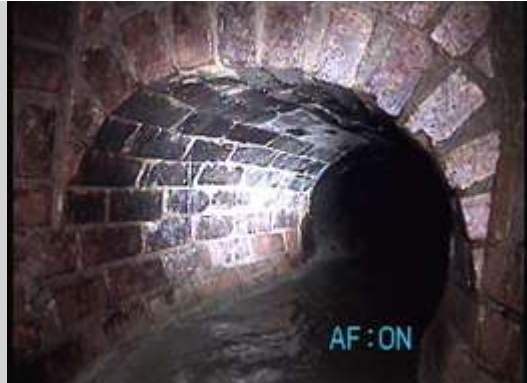
12 O'Clock Outflow

Pipe Height: **24** (in.) Rod and Bar (Angled)
Pipe Material: **Clay** ☐ Pipe Lined
Invert Depth: **13.55** (ft.) Flow Characteristics: **Fast**
Deposits: ☒ None ☐ Mud ☐ Sludge ☐ Debris ☐ Grease
Silt Depth: (in.) Deposits Extent:
Infiltration: **None** Pipe Seal Cond: **Sound**

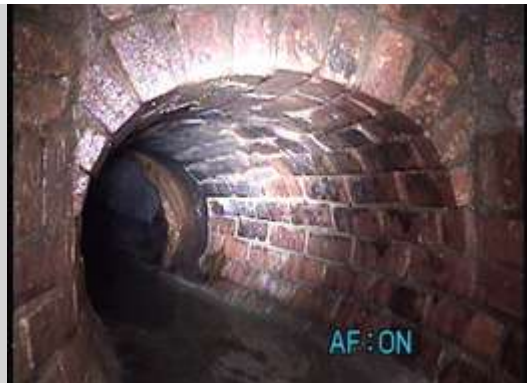
4 O'Clock Inflow

Pipe Height: **21.6** (in.) Rod and Bar (Angled)
Pipe Material: **Clay** ☐ Pipe Lined
Invert Depth: **13.60** (ft.) Flow Characteristics: **Fast**
Deposits: ☒ None ☐ Mud ☐ Sludge ☐ Debris ☐ Grease
Silt Depth: (in.) Deposits Extent:
Infiltration: **None** Pipe Seal Cond: **Sound**

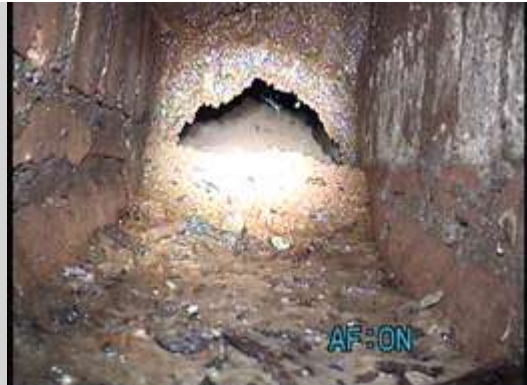
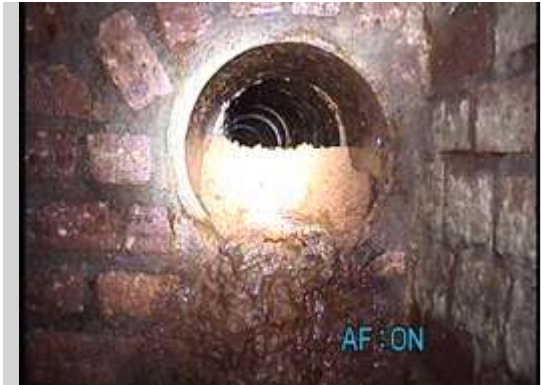
Drop: **Inside**

Drop Condition: **Partly Clogged**
